# Combined Building and Pest Report

**0001 Example St, Suburb, QLD, 4212**

Report/Agreement #	091225010807477
Inspection Date:	09 Dec 2025
Inspection Time:	01:08 pm

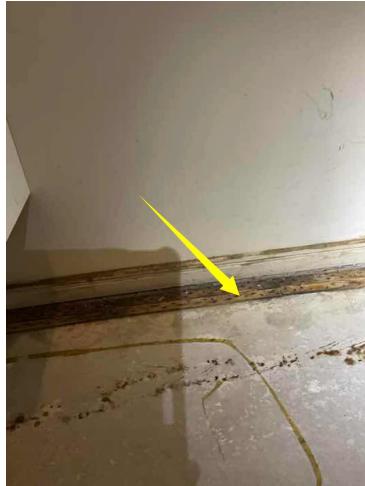
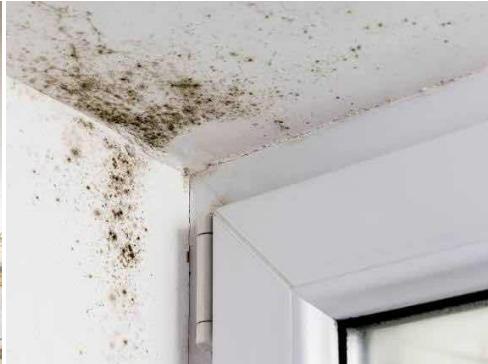
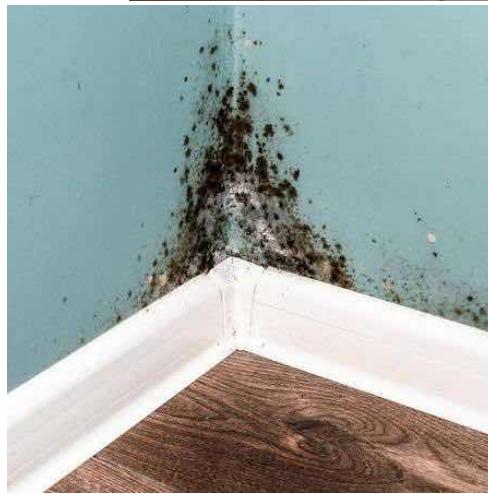
**Mould observed.**

#2. There is evidence of mould in the structure. Read report.

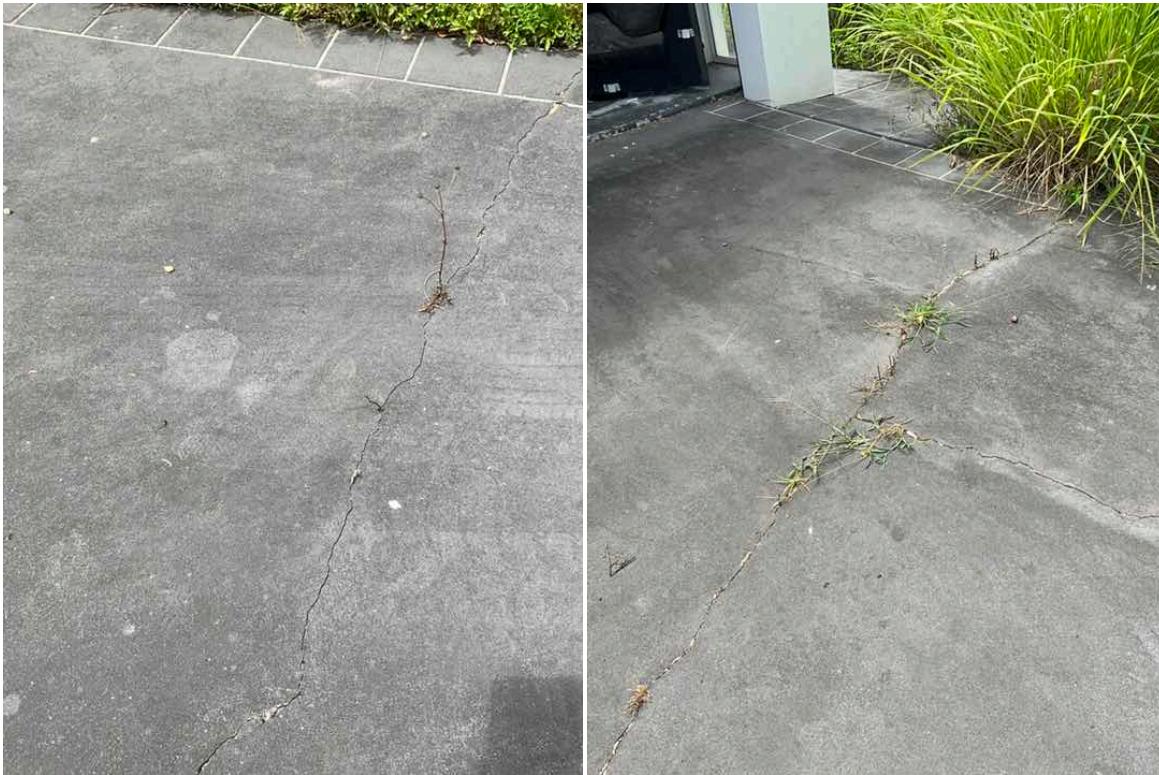
#4. Common cracks & settlement were observed on the driveway. Note: Whilst these cracks appeared to be minor at the time of inspection, we strongly recommend you monitor these cracks and if worsening occurs contact a concreter for further advice.

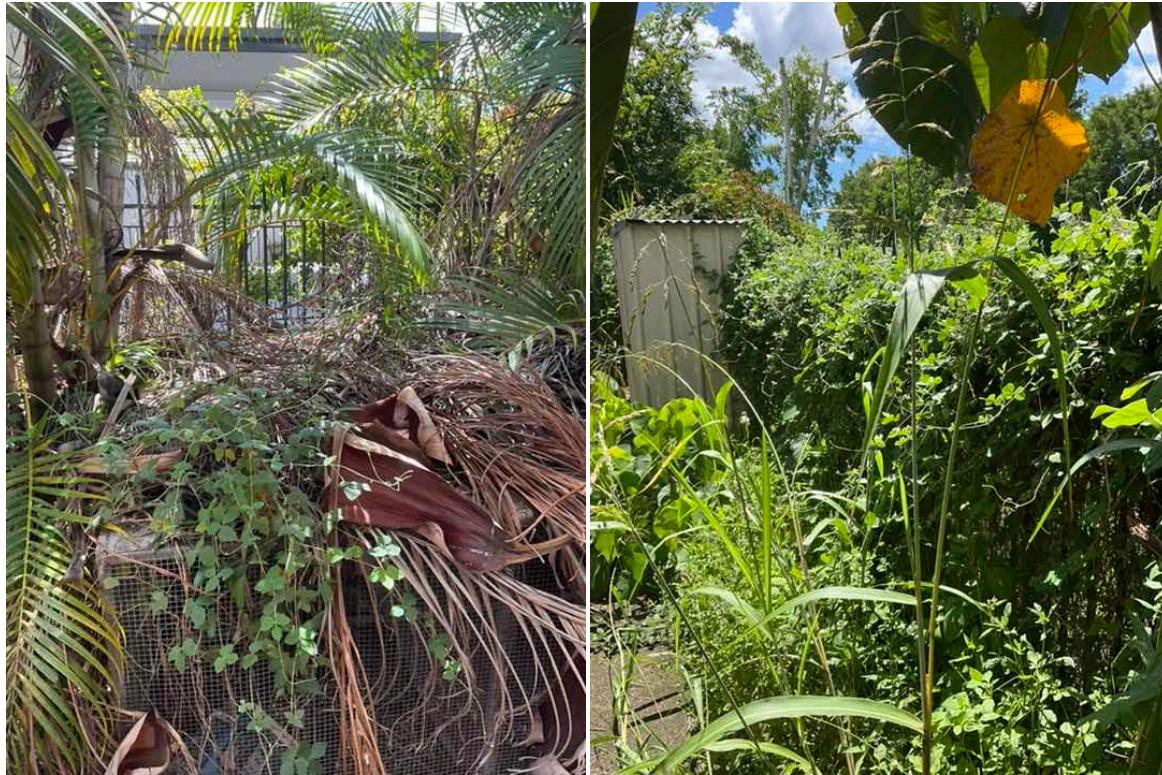
There is vegetation/vines on fence which are very heavy. This should be removed as it will eventually pull the fence over.

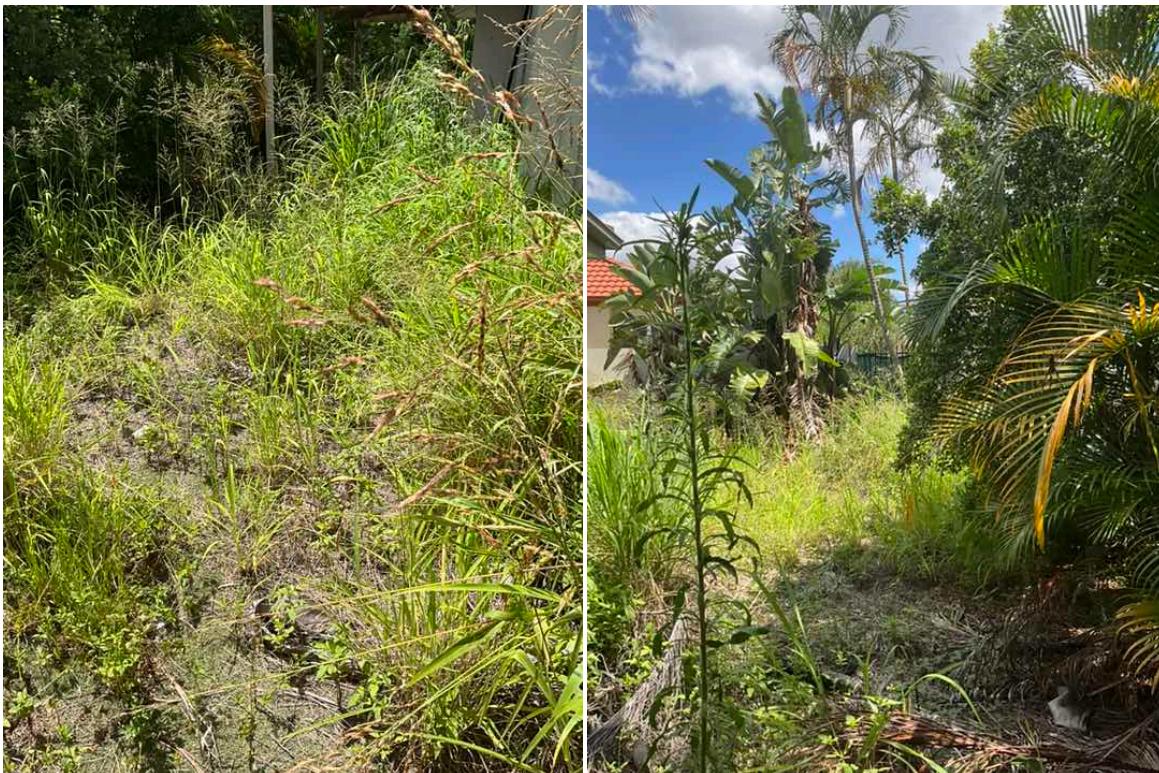
#7. There is evidence around the home that ponding has occurred. Recommendations: A qualified landscaping contractor or a plumber should be engaged for advice and recommendations.

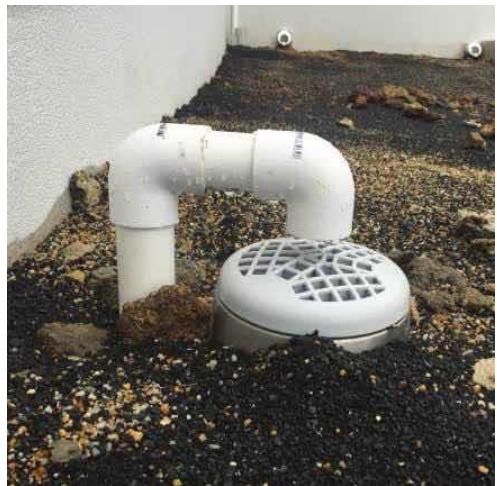
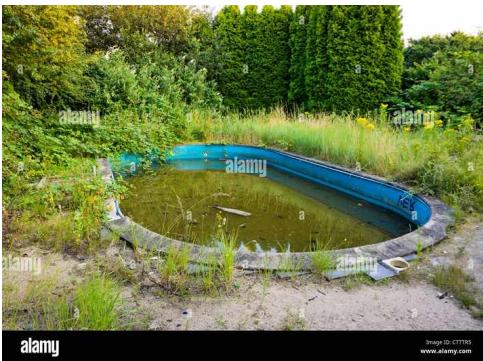
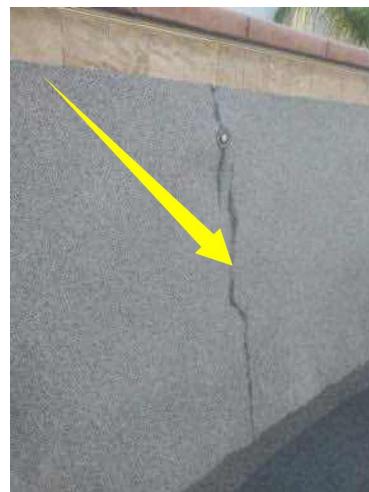
- #14. The fence requires minor repairs. Consult QBCC licensed fencer.

- #15. The pool is showing signs of surface deterioration. Consult QBCC licensed pool specialist.

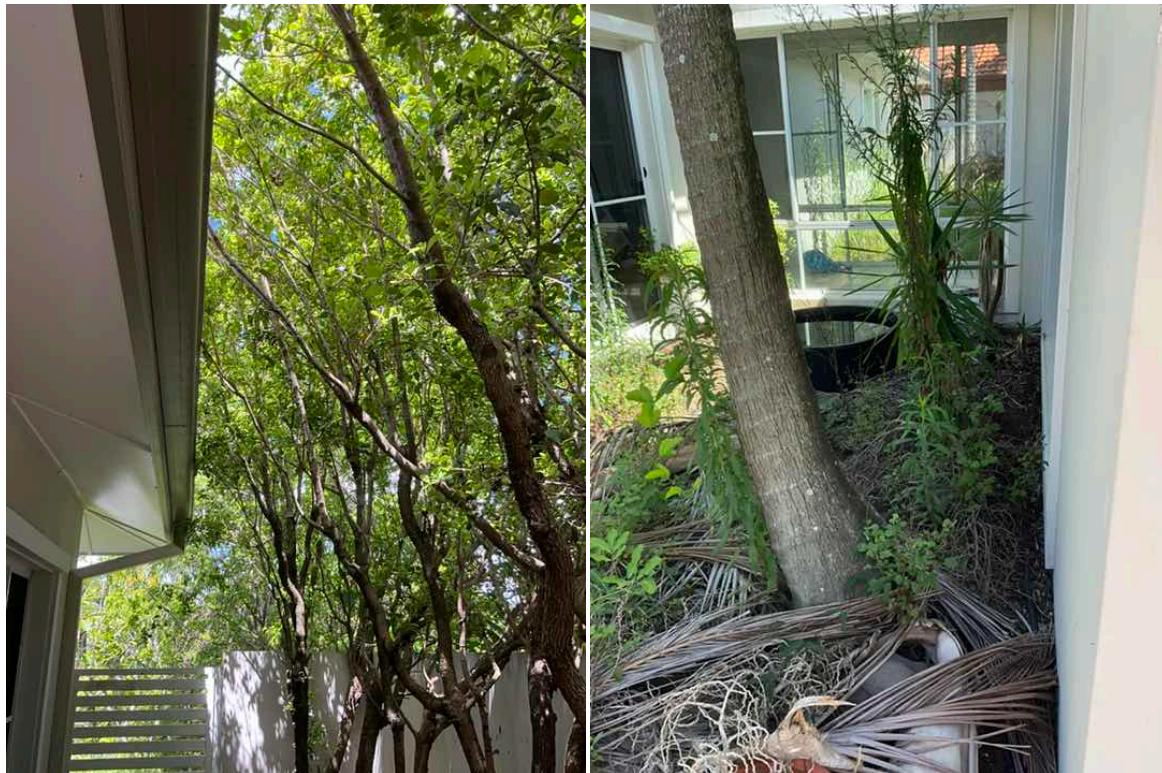
#16. Trees are overhanging roof areas. Recommendations: These should be cut back away from the roof line and gutters.

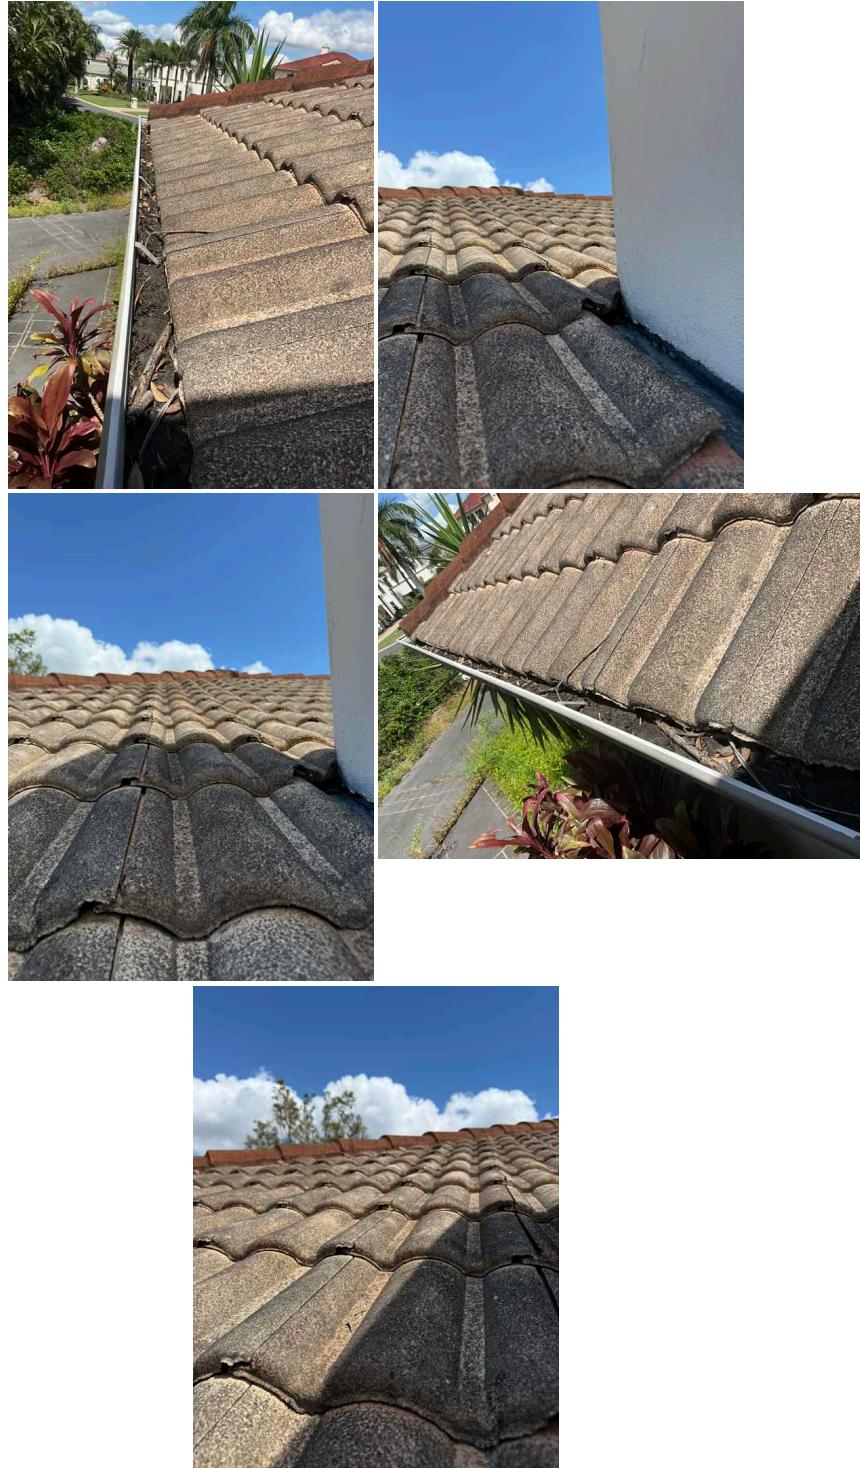
#18. Deterioration & ageing evident. This includes all flashings fittings and roof penetrations. I recommend you contact a roof restorer to clean, seal, and repoint the mortar (not required on metal roofs).

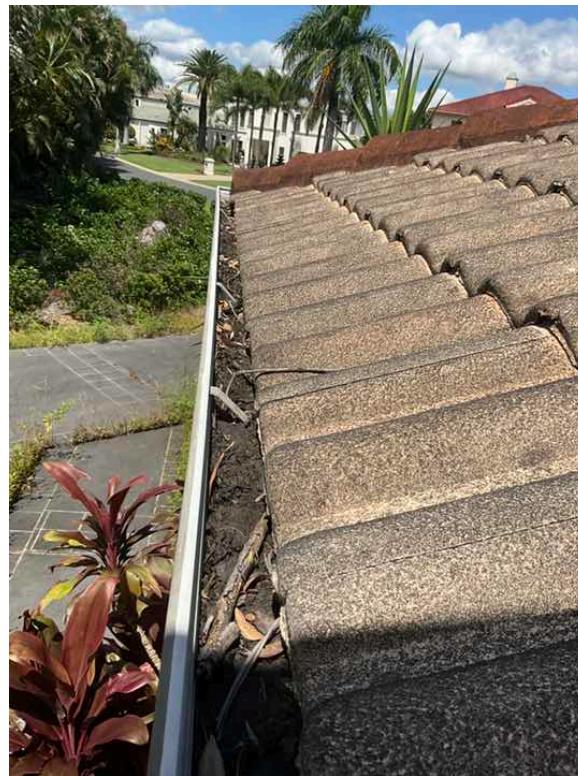
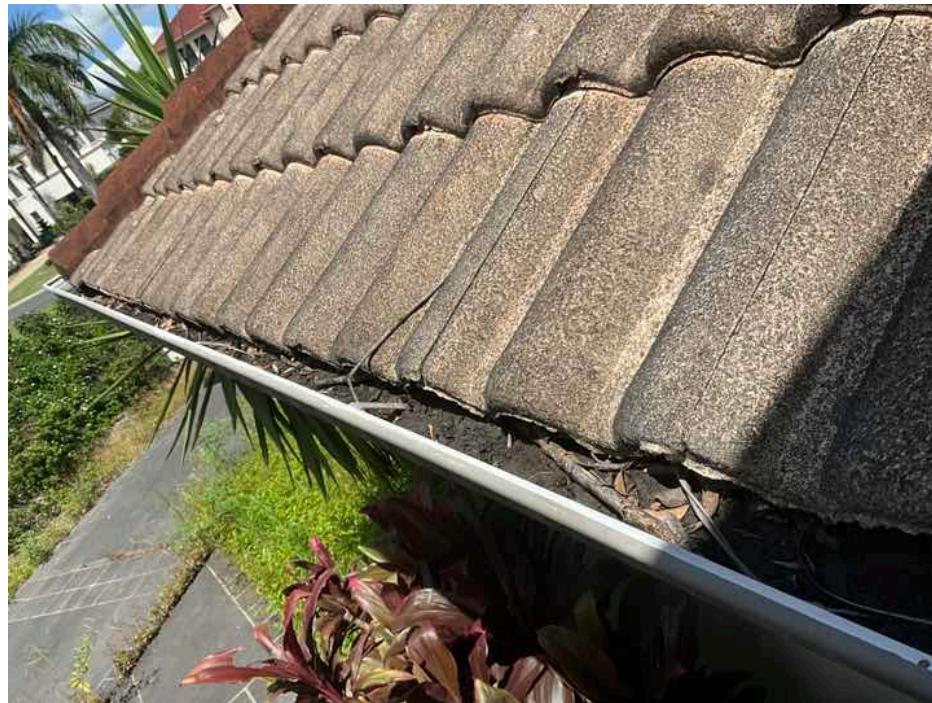
#19. Debris in guttering areas- this requires cleaning out to prevent blocking of down pipes and leaking into eaves and fascia. Recommendations: Have gutters cleaned and assessed by a plumber for adequate fall. Also regularly clean to prevent ponding. Ponding water will contribute to rust.

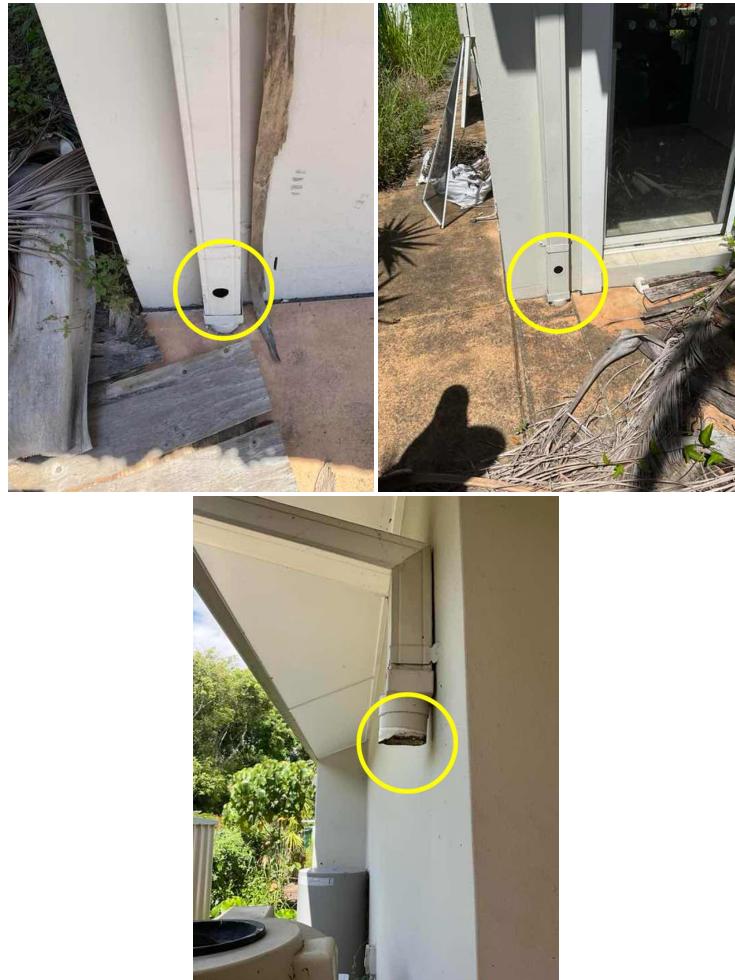
#20. Down pipe/s not connected to storm water discharge - Down pipes not connected to storm water have the potential to cause differential settlement to the footings, cause rising damp and is also conducive to termite infestation. Recommendations: A qualified plumber should be engaged for advice and recommendations.

#21. Hole in downpipe. Consult a plumber for repair/replacement.

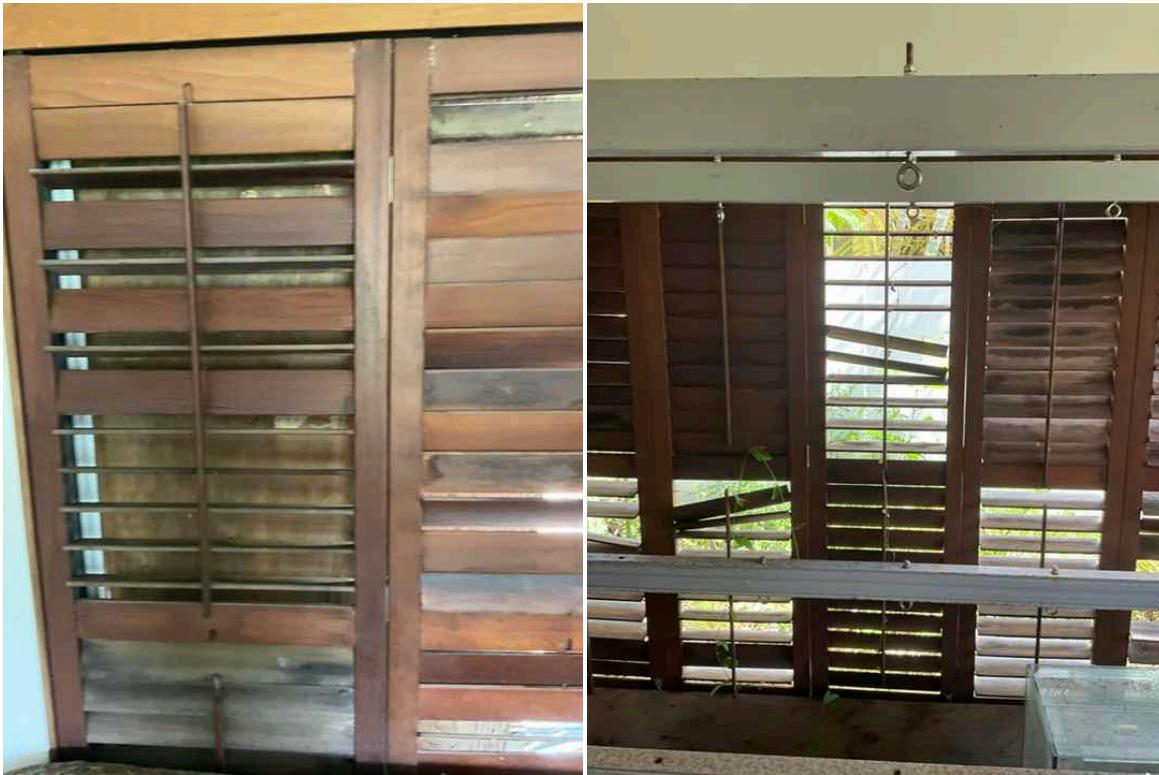
#24. The frame timber requires sanding and painting to seal from weather conditions.

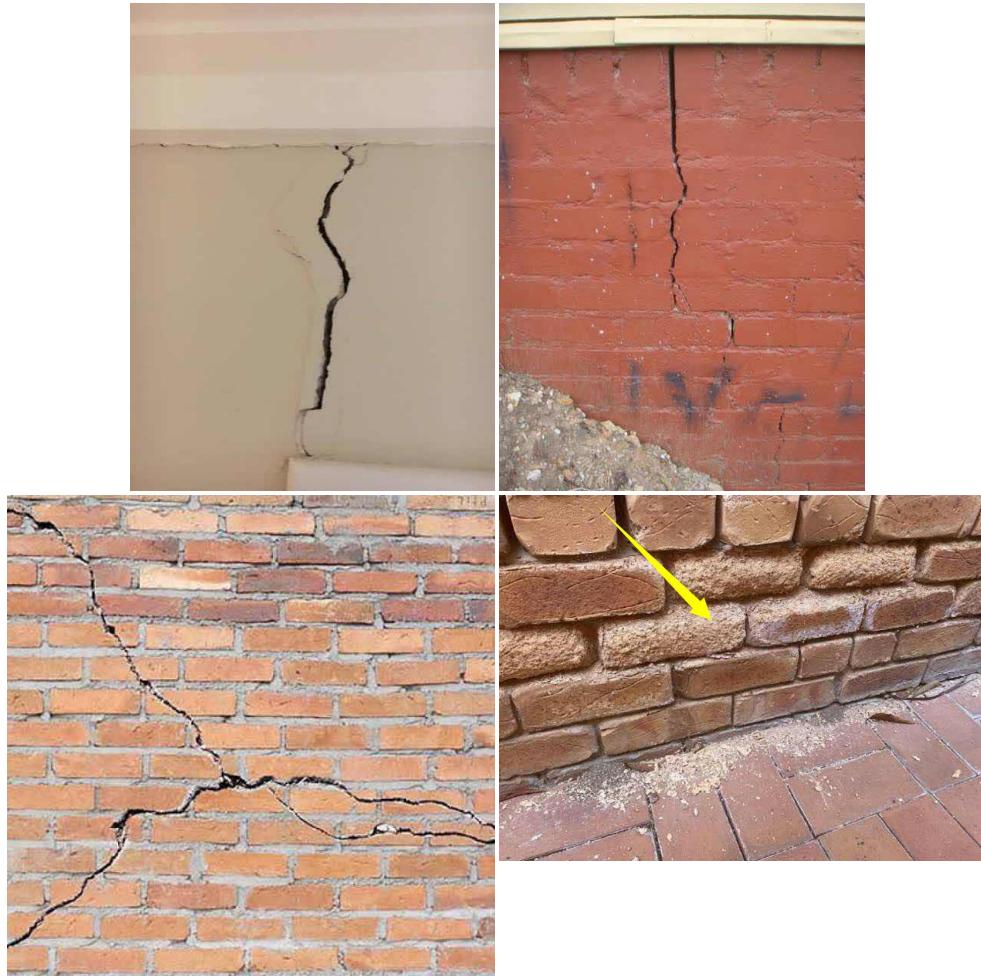
Brick spawling/cancer noted in some bricks.

Have repaired by a licensed brick layer. This is urgent as bricks could crack and shatter causing structural subsidence of the dwelling . Contact a licenced rising damp specialist and licenced brick layer for advice.

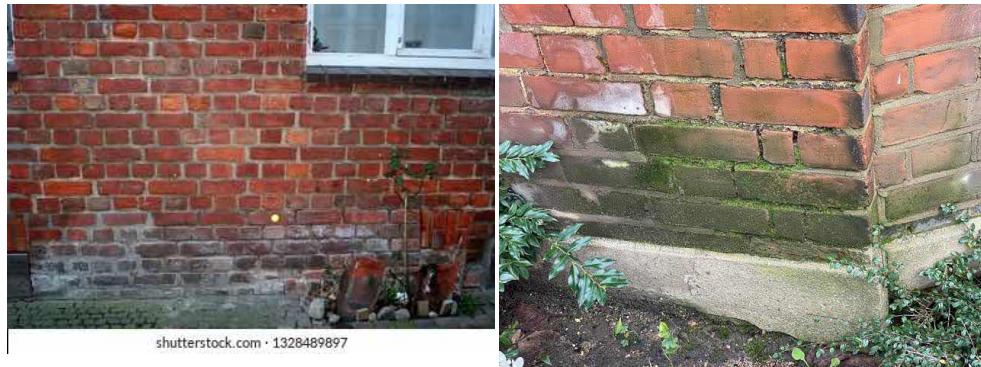
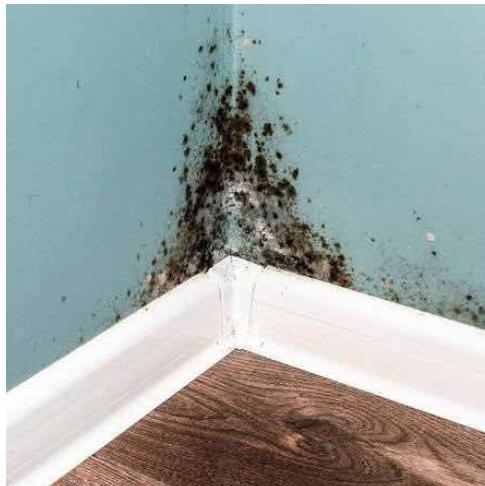
#30. Evidence of rising damp issues. Consult QBCC qualified waterproof specialist.

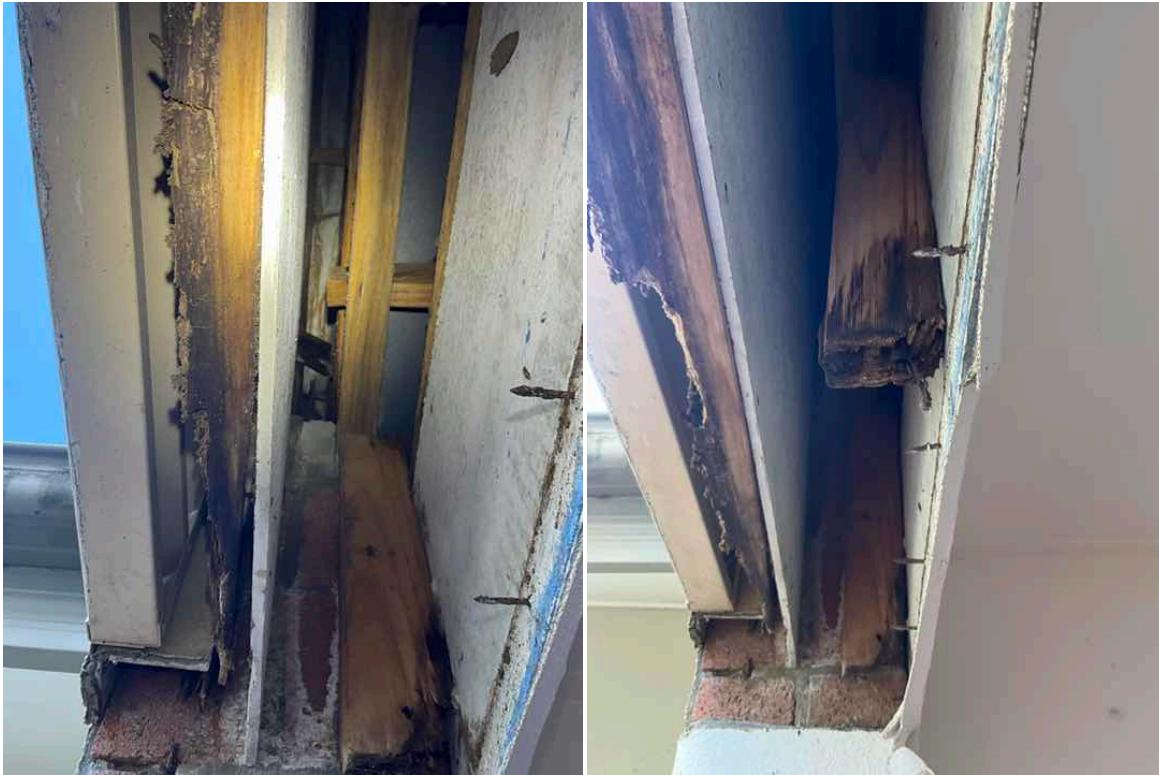
#31. Timber decay (rot) visible. Recommendations: A qualified carpenter should be engaged to replace all affected timbers.

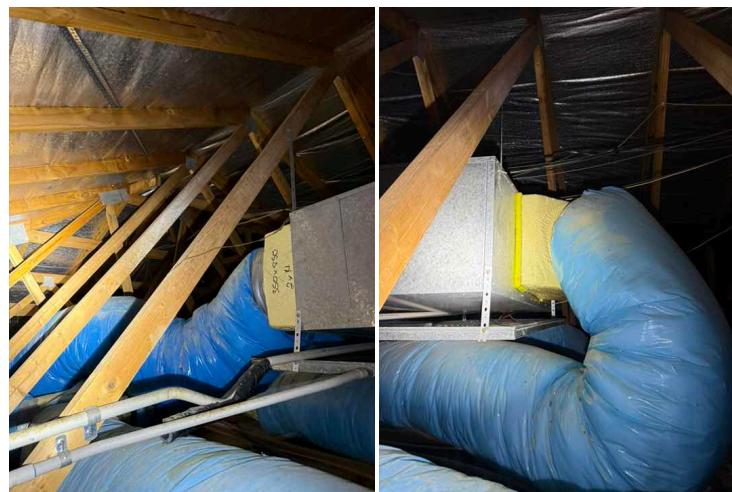
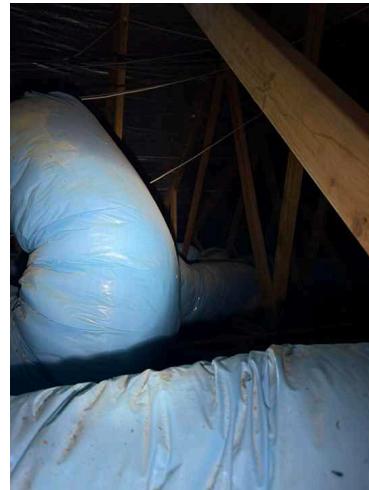
#32.

EXTERIOR	Air Conditioner	Condition defects	<p>#32.</p> <p>Air conditioning ductwork must be suspended in accordance with Australian standard 4254.1–2012 and the National construction code. Flexible ductwork should be supported horizontally every 1.5 m and vertically every 1.8 m. The maximum sag between Support is 2.5 cm per 30 cm of horizontal run.</p> <p>Long horizontal duct with sharp bends should have additional support.</p> <p>The hanger or saddle material should be wide enough to prevent restricting the ducts internal diameter. A semi rigid fire resistant load distributing support material must be at least 75 mm wide.</p> <p>Flexible ductwork Installed in subfloor site must be supported so that no part of the duct touches the ground. All flexible ductwork must be labelled flexible ductwork must extend straight for 100 mm from the connection to an air terminal device before changing direction.</p> <p>Consult and air-conditioning specialist for rectification.</p>

Consult and air-conditioning specialist for rectification.

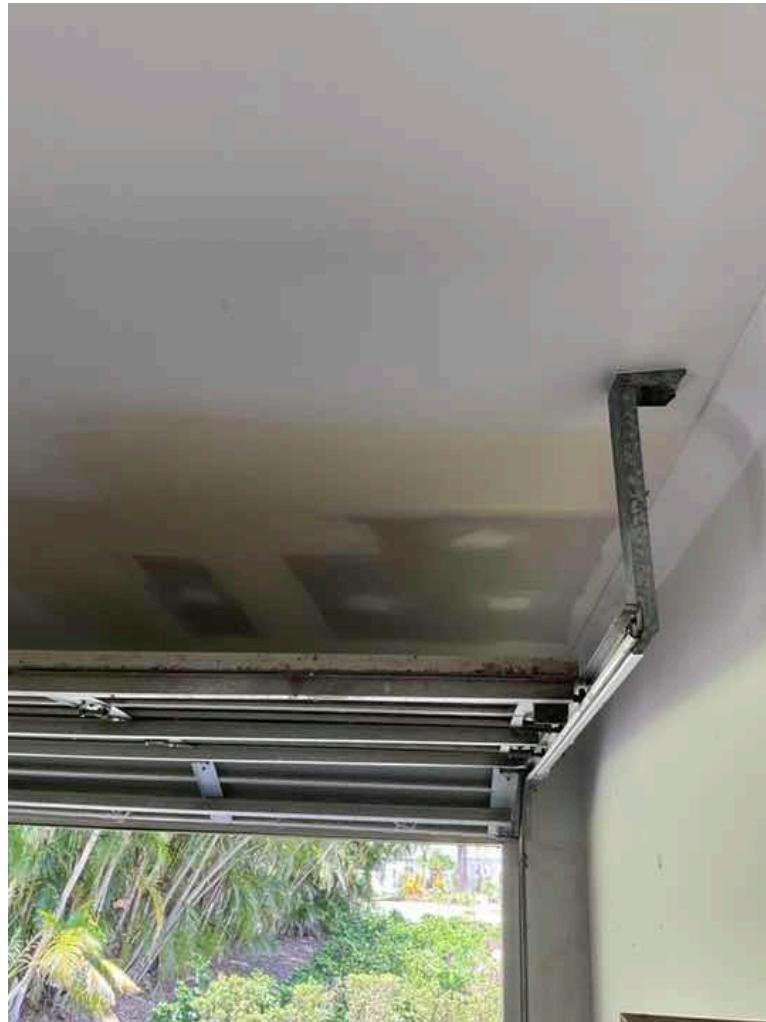
#33. A repair has been completed.

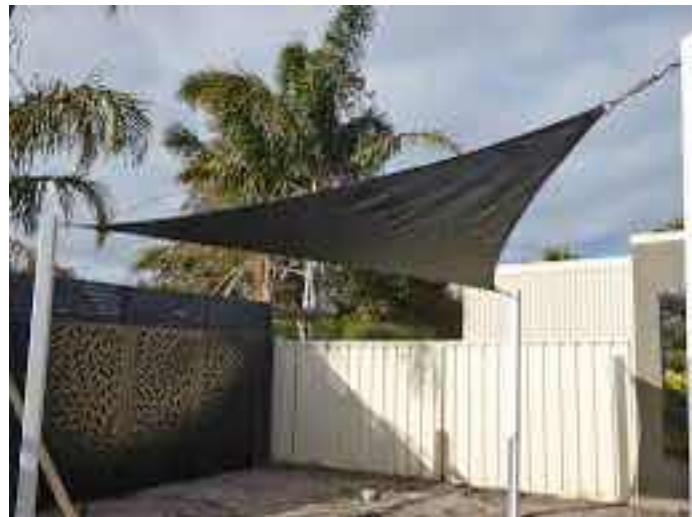
#34. Shade sails, car ports and roofed pergolas are considered under the national construction code and The Council as a 10a structure and as such requires council approval through a private certifier. Client should make all necessary requirements for certification.

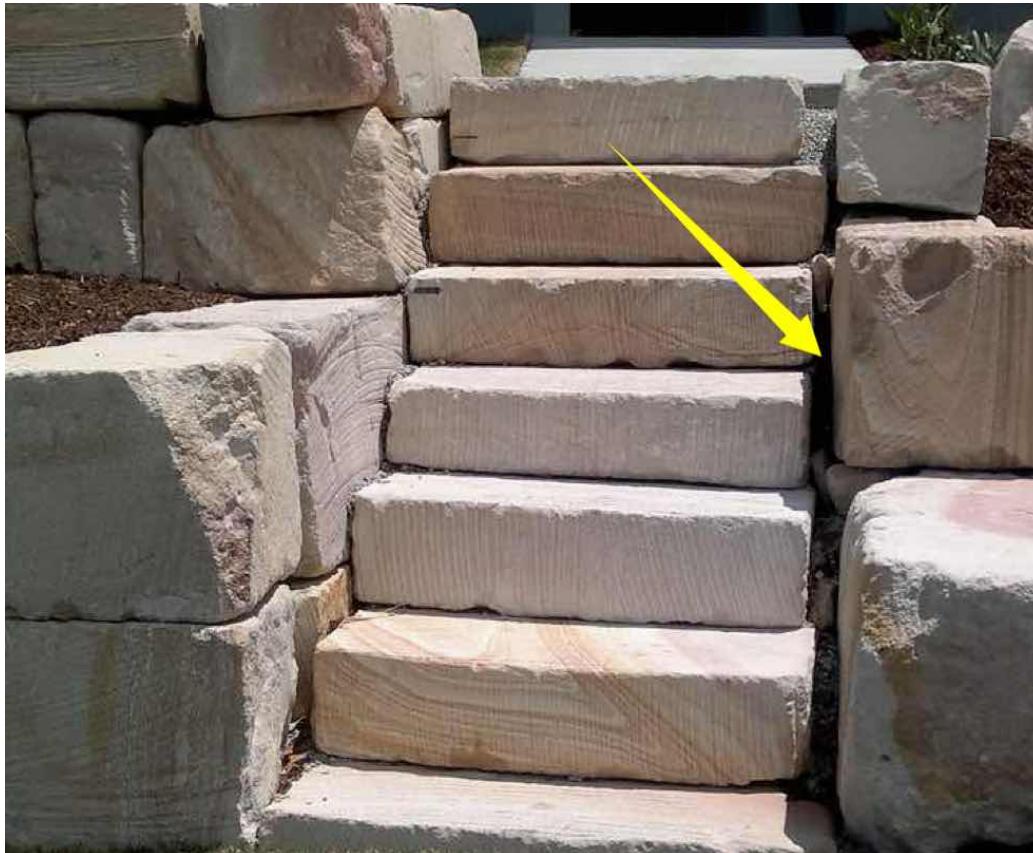
#35. The stairs do not have an approved handrail. The National Construction Code of 2015 3.9.2.4 (a) Handrails to a Starway must (1) be located along at least one side of a flight or ramp and, (2) be located along the full length of the flight or ramp (3) have a top surface of the handrail not less than 865 mm vertically above the treads . NCC 3.9.2.4 (b) If there is a winder or turn on the stairs a newel post or handrail is required . and AS 1657-2013. Every stairway will be provided with at least one handrail, where there is more than 5 stairs or the height is more than 1 meter and on a wind. Consult a qualified tradesman for advice.

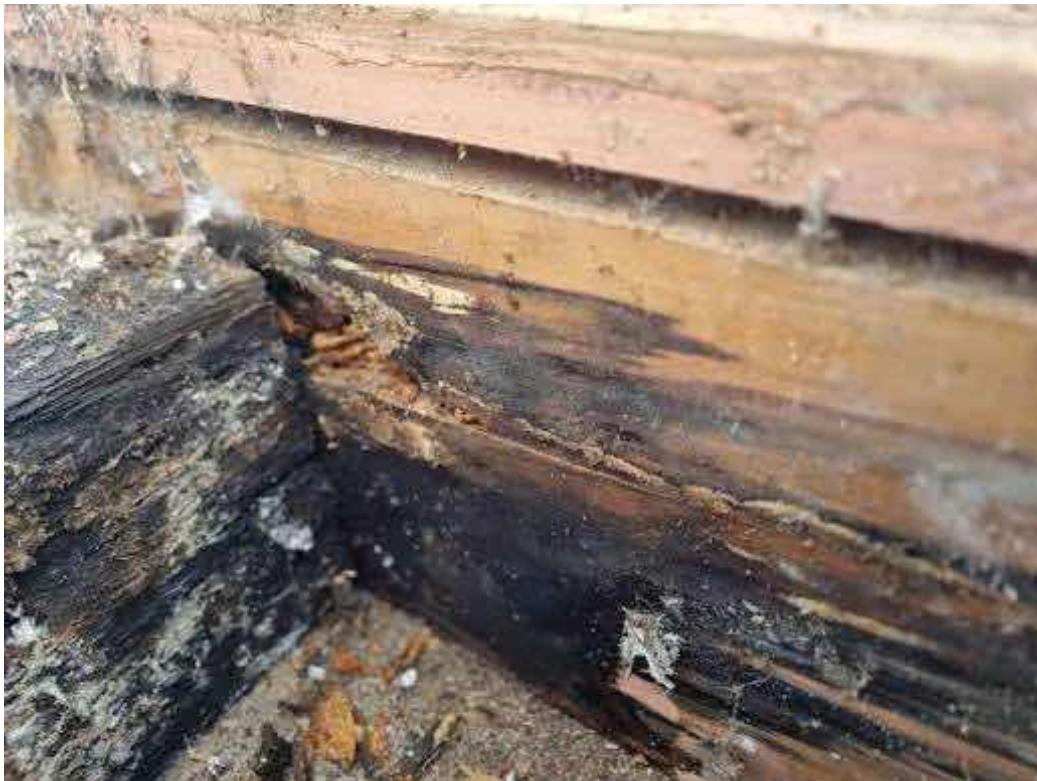
#37. Timber decay in section of bearers or joists. This is a safety hazard and repair is required. Recommendations: A qualified carpenter should be engaged to replace all affected timbers.

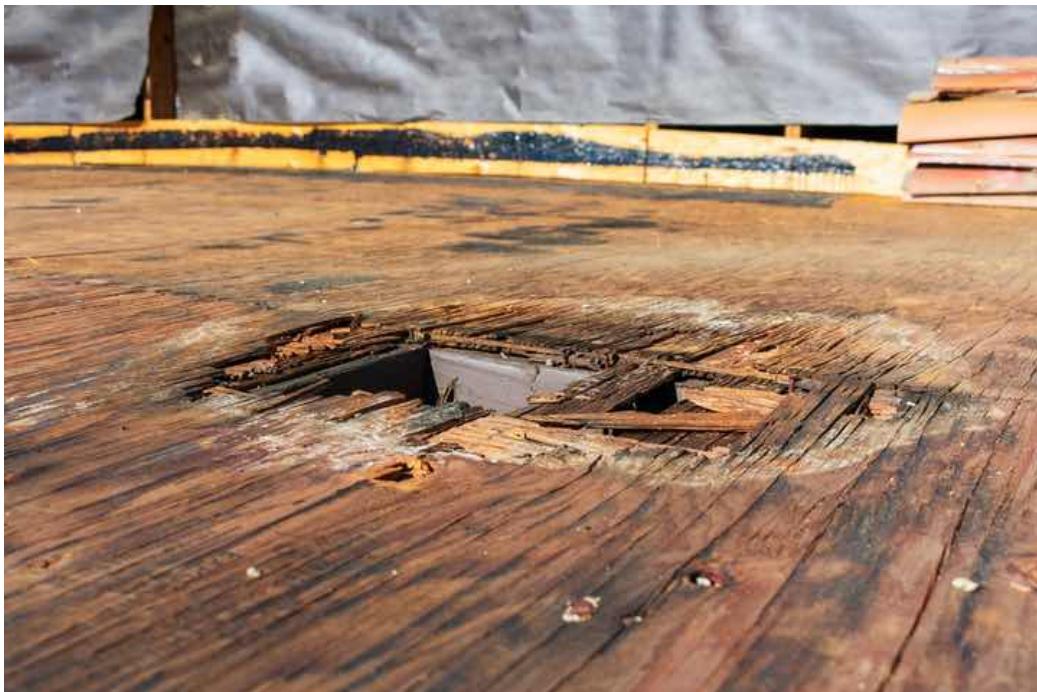
#38. Moisture damage was observed on deck boards - Recommendations: Evaluation and repairs by a qualified decking contractor.

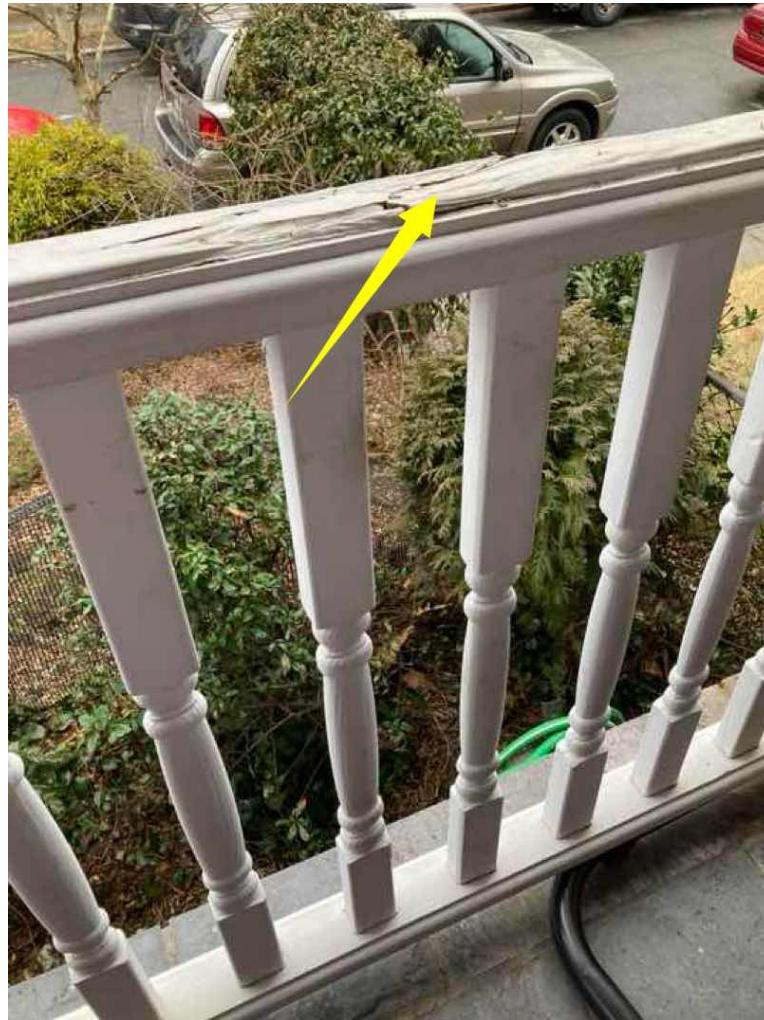
#39. Timber decay in areas of balustrade and/or rails. Recommendations: A qualified carpenter should be engaged for advice and recommendations. This is a safety issue and requires immediate assessment.

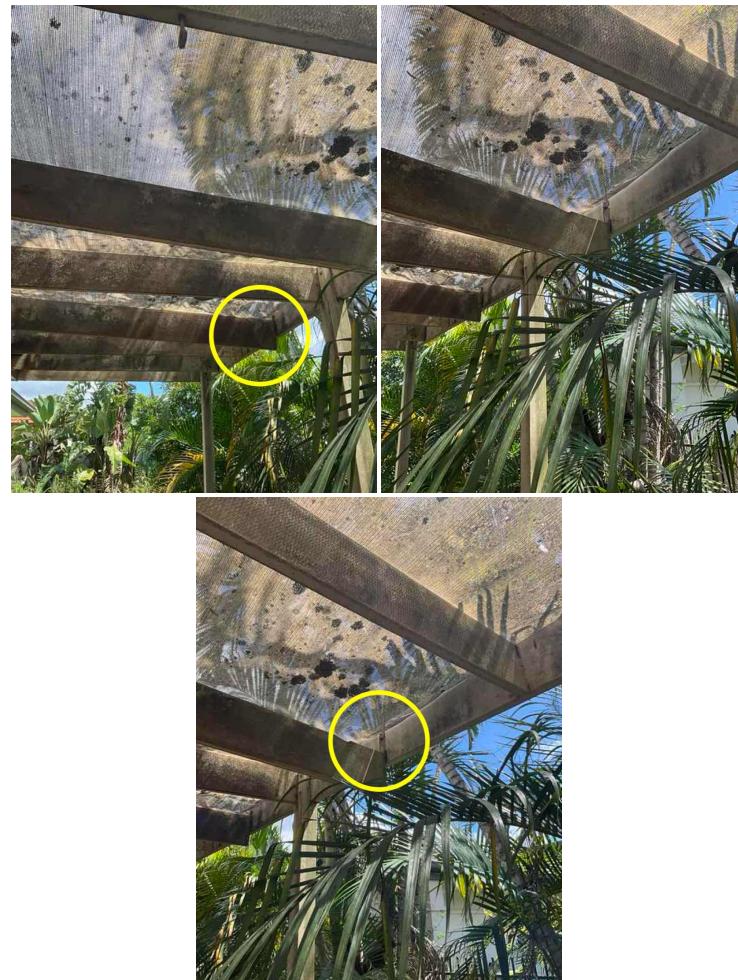
#42. The pergola has numerous defects concerning construction which renders the structure to failure. Consult carpenter.

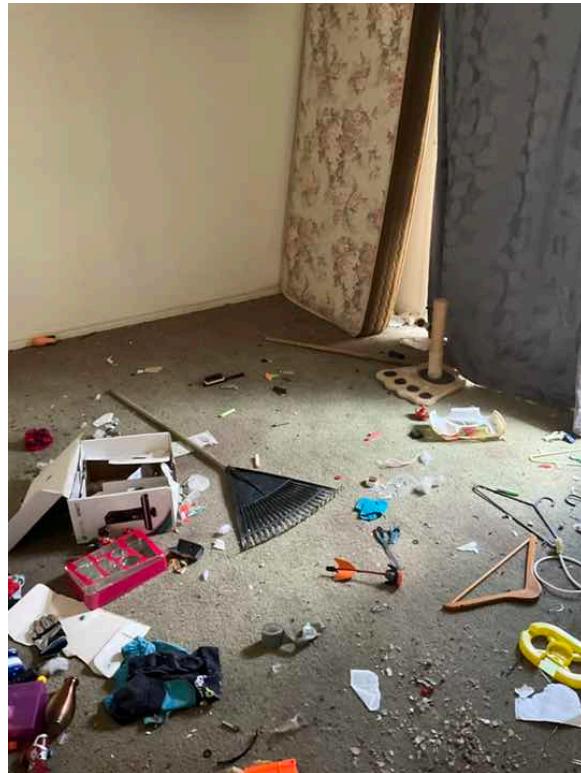
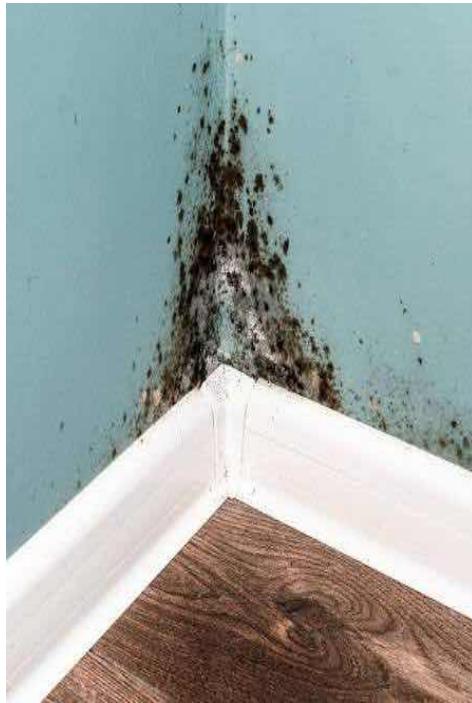
#44. Area of ceiling and wall shows signs of water damage. Mould evident. This is a health hazard. Contact a qualified tradesman for advice.

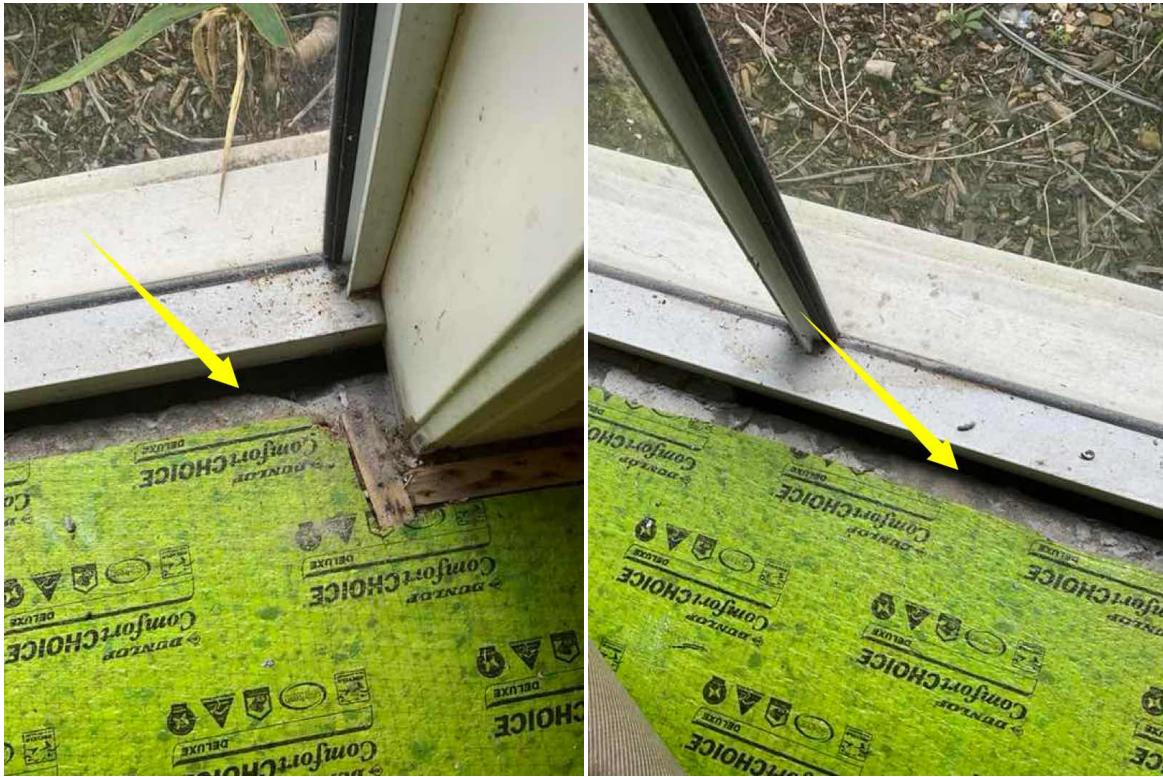
#45. The window has been installed with excessive cap between widow and slab. This causes moisture ingress and poor operation of the flashing. The window should be removed and reinstalled to NCC codes with sill etc installed.

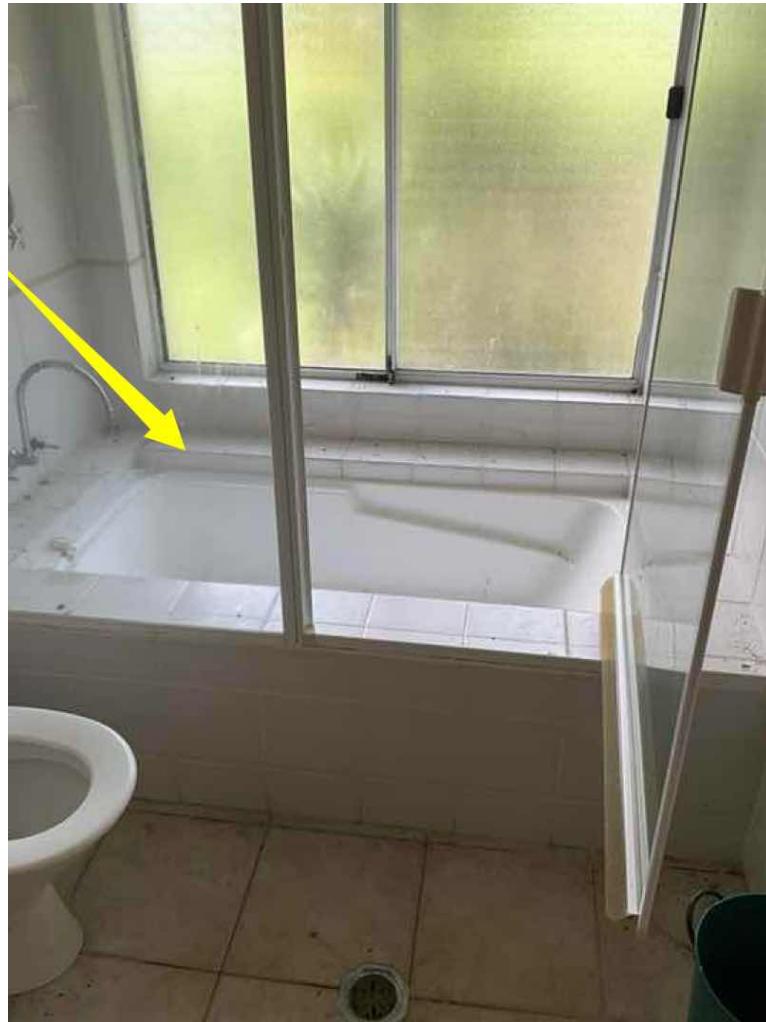
#46. Aged renovate. Consult QBCC licensed builder.

#47. Tile grout deterioration to tiles around the bath . Re-grout / seal. A qualified tiler should be engaged recommendations and repairs

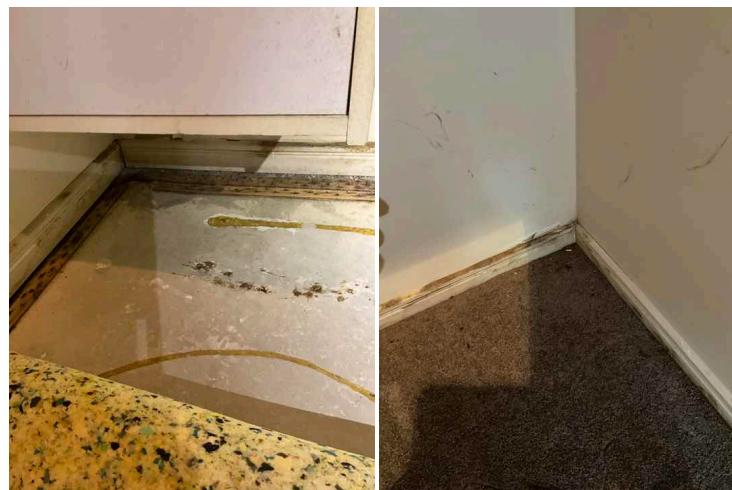
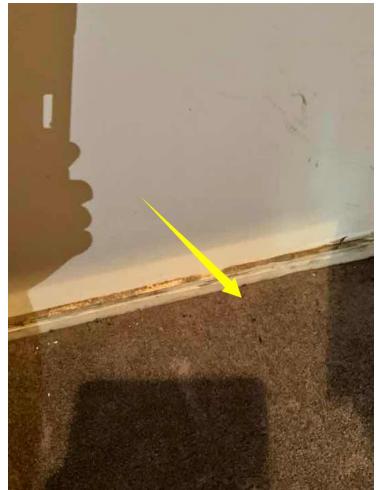
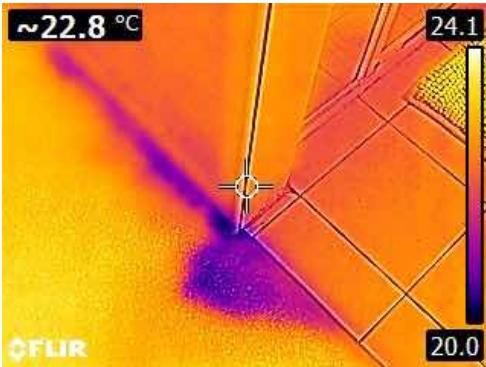
#50. High moisture readings in cavity wall. A flood and pressure test for the pipework and membrane should be conducted. Consult QBCC qualified plumber.

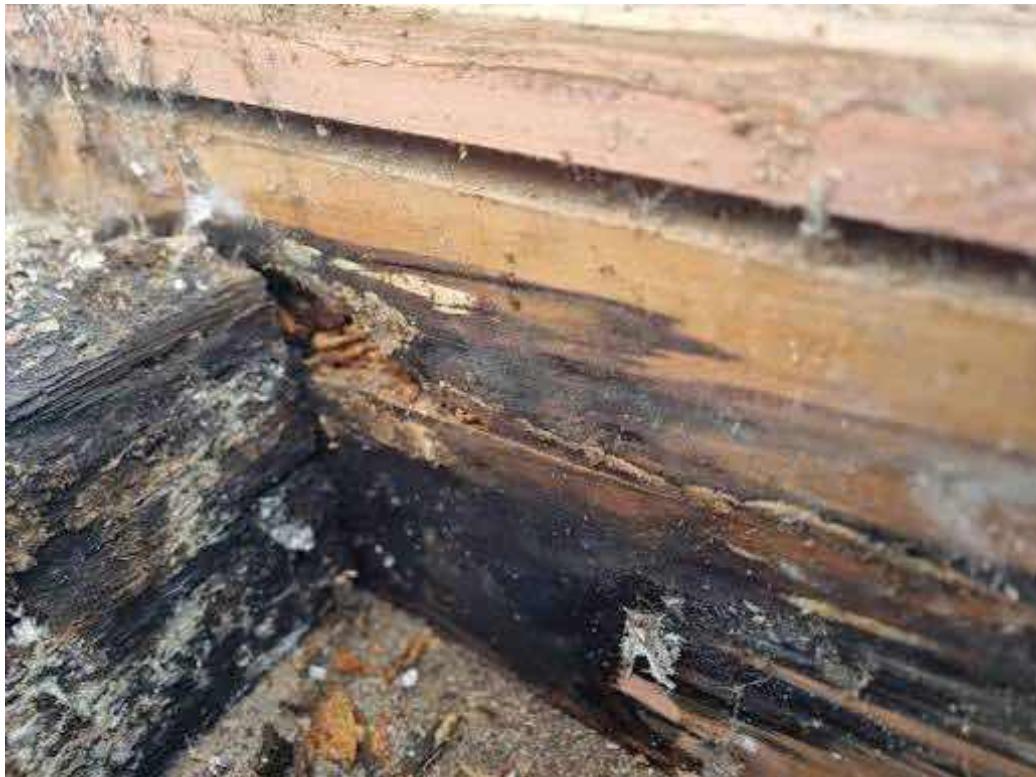
#52. Yes, in the following areas deck area. Area requires a treatment. Contact a license pest company.
