# Combined Building and Pest Report

**0001 Example St, Suburb, QLD, 4212**

Report/Agreement #	091225010807477
Inspection Date:	09 Dec 2025
Inspection Time:	01:08 pm

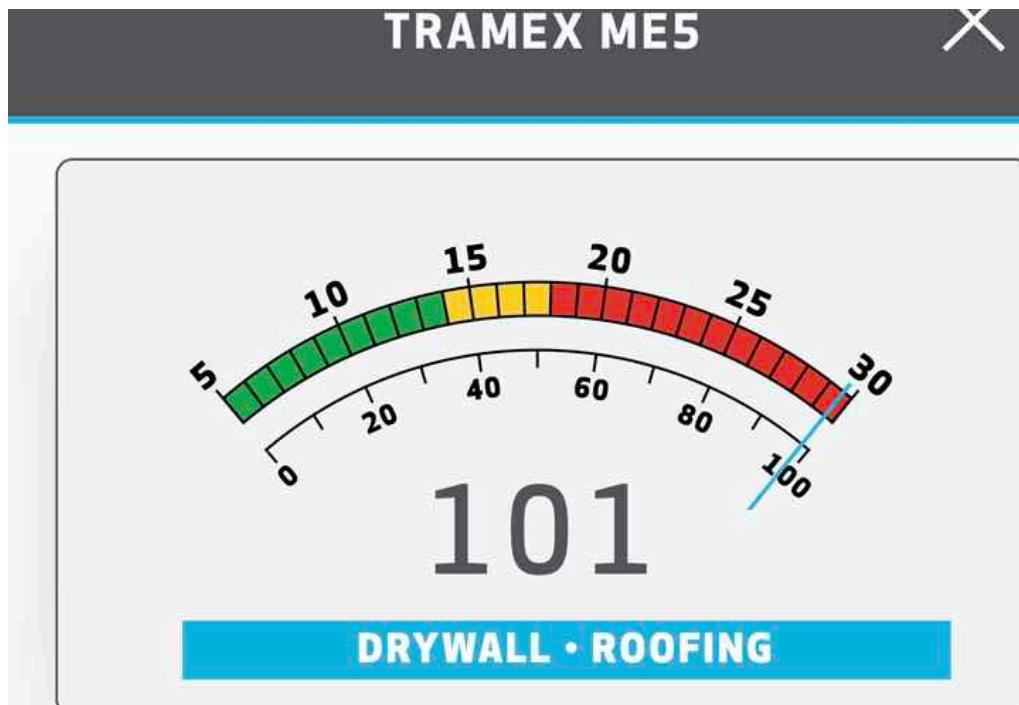
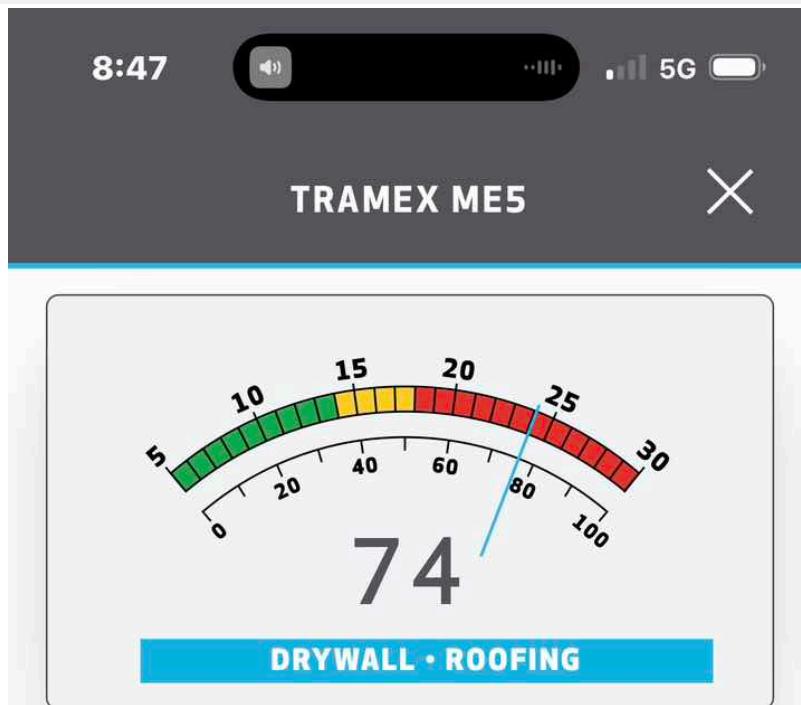
At the time of the inspection moisture readings were high

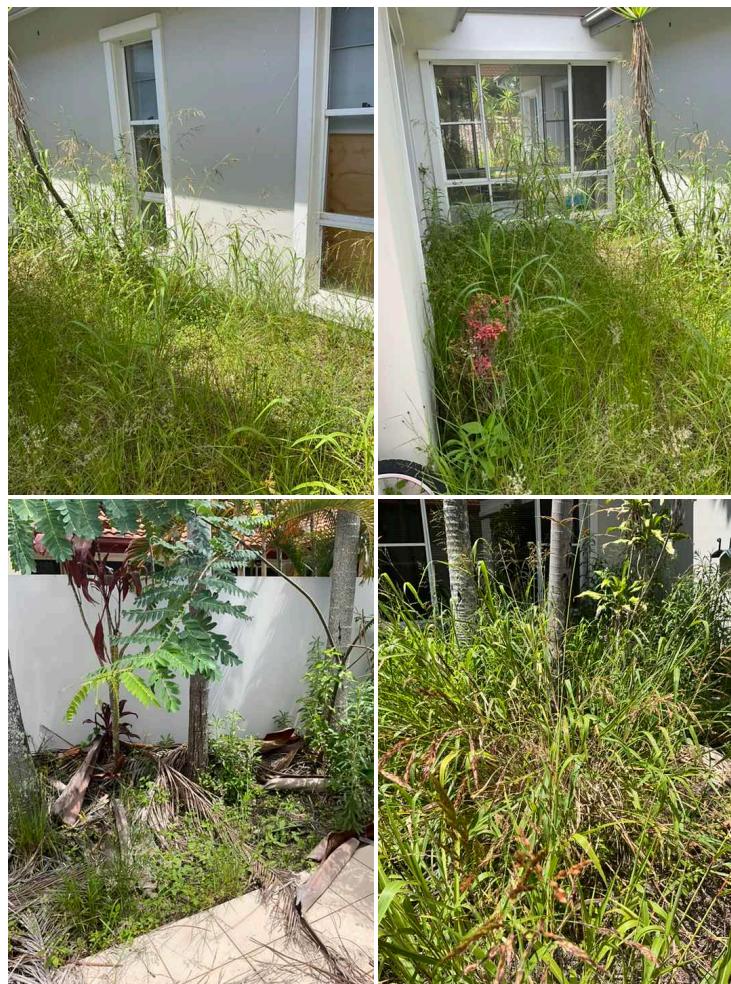
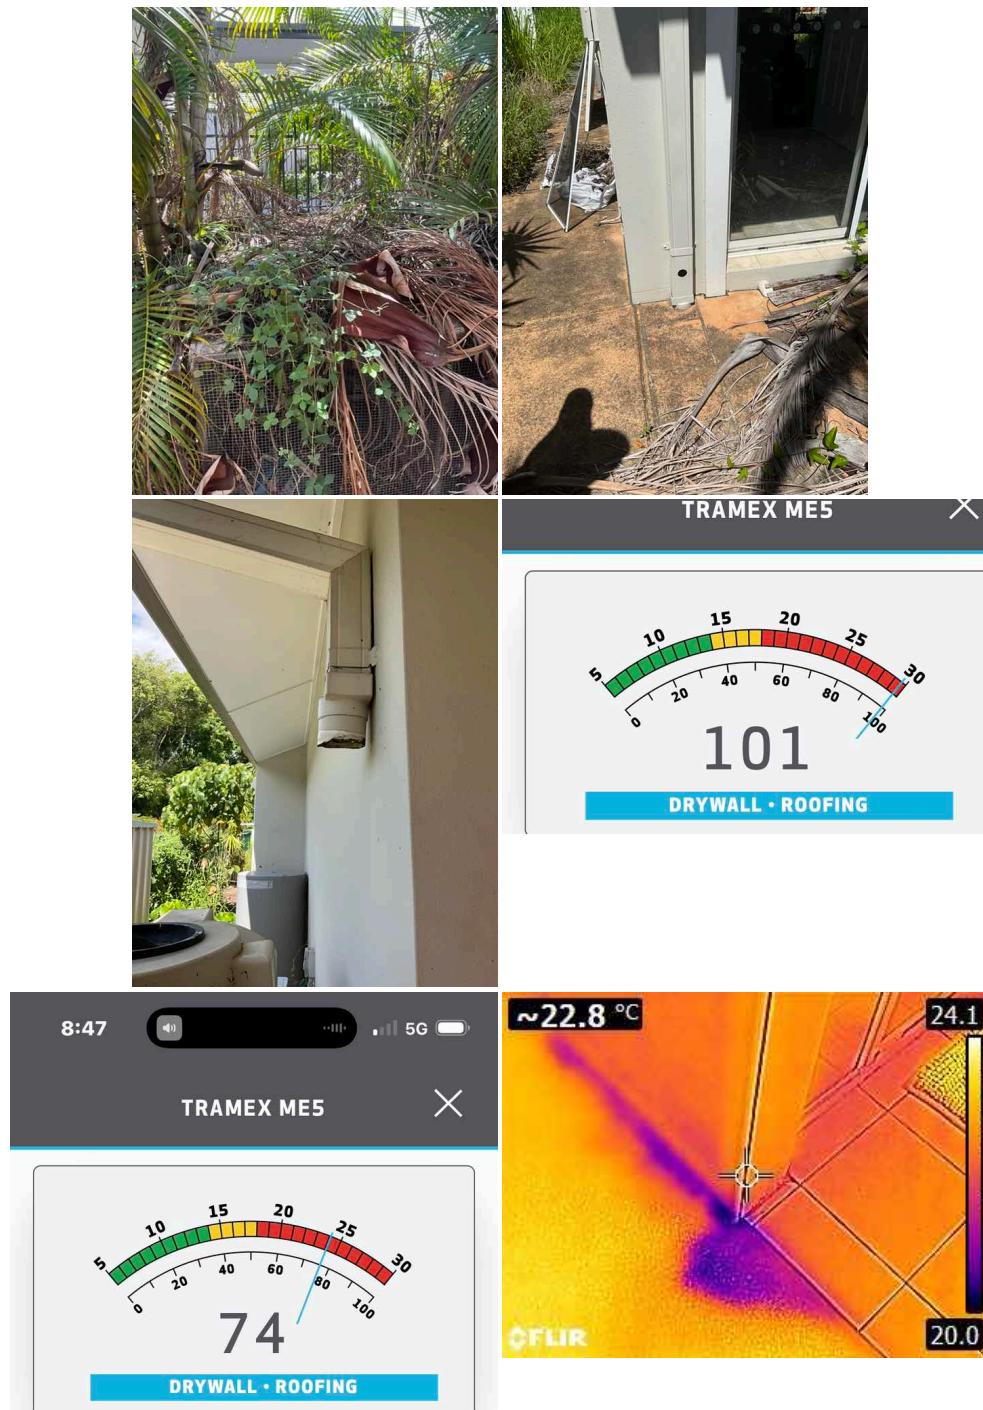
#60. High moisture readings detected in cavity wall which is conducive to termites.
