# Combined Building and Pest Report

**0001 Example St, Suburb, QLD, 4212**

Report/Agreement #	091225010807477
Inspection Date:	09 Dec 2025
Inspection Time:	01:08 pm

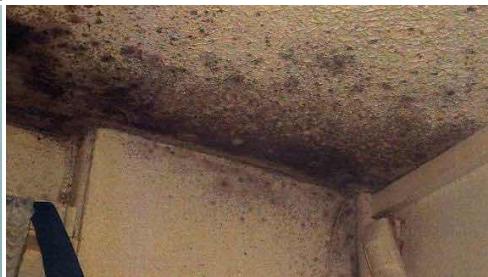
**Mould observed.**

#2. There is evidence of mould in the structure. Read report.

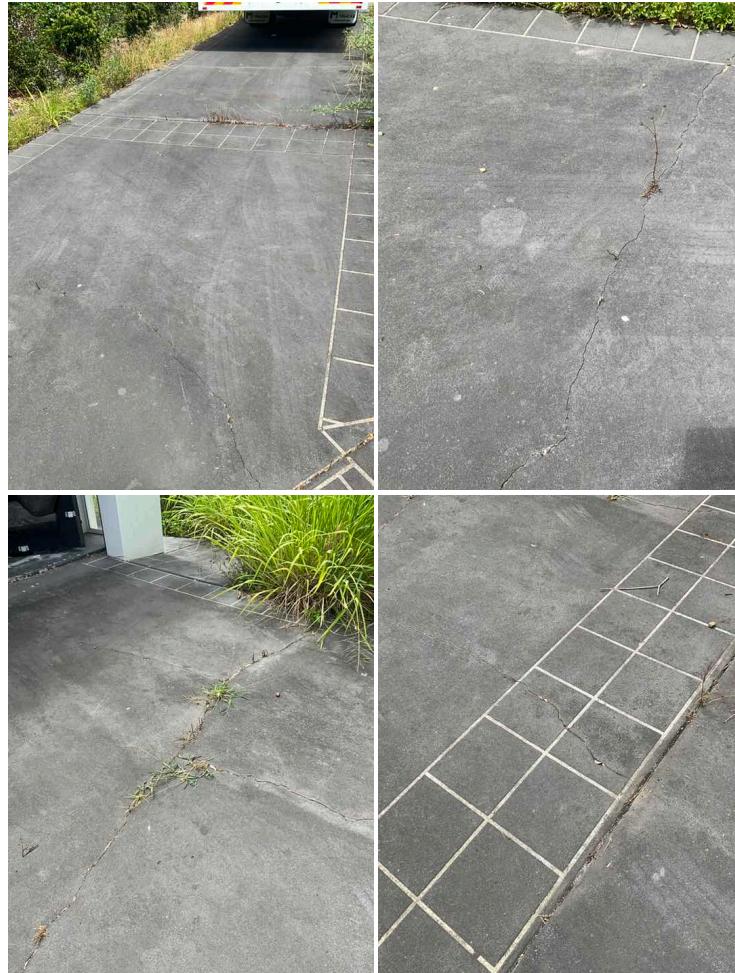
**Driveway Condition**

#4. Common cracks & settlement were observed on the driveway. Note: Whilst these cracks appeared to be minor at the time of inspection, we strongly recommend you monitor these cracks and if worsening occurs contact a concreter for further advice.

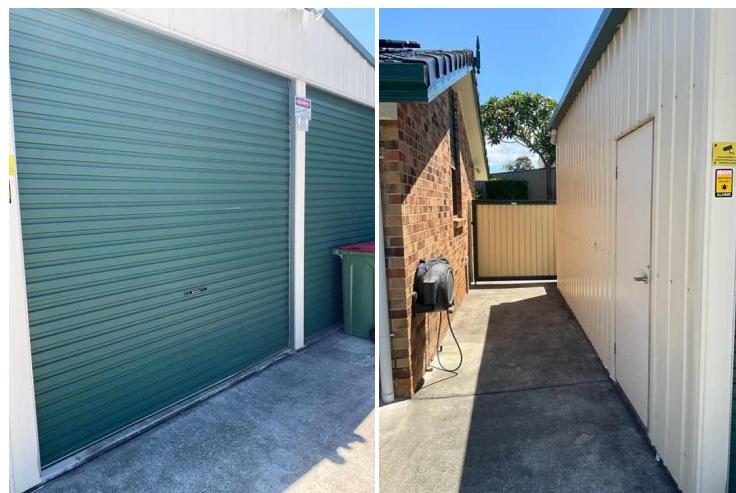
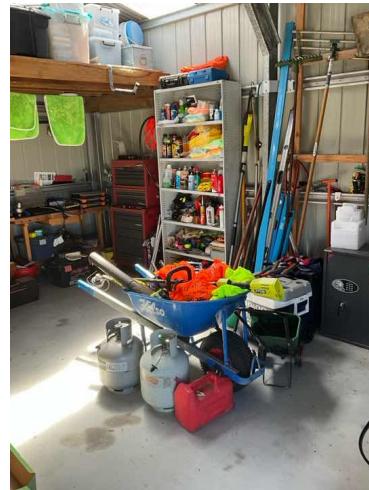
## Shed

#8. Check for certification and council approval.

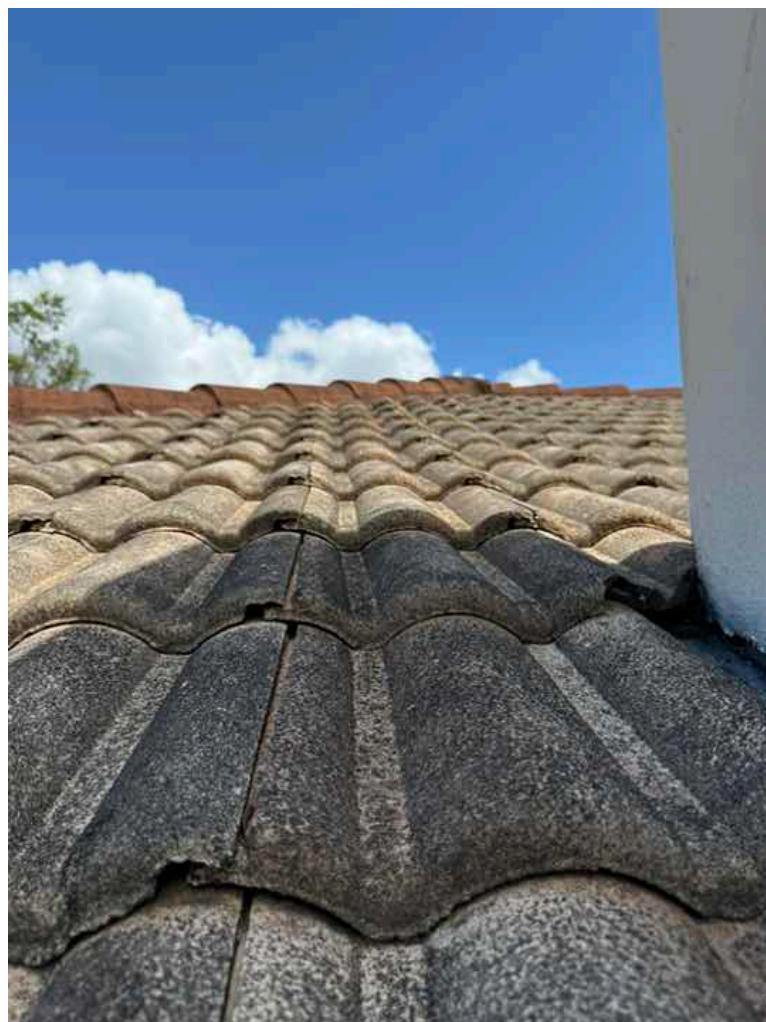
## Roof Clad Condition

#18. Deterioration & ageing evident. This includes all flashings fittings and roof penetrations. I recommend you contact a roof restorer to clean, seal, and repoint the mortar (not required on metal roofs).

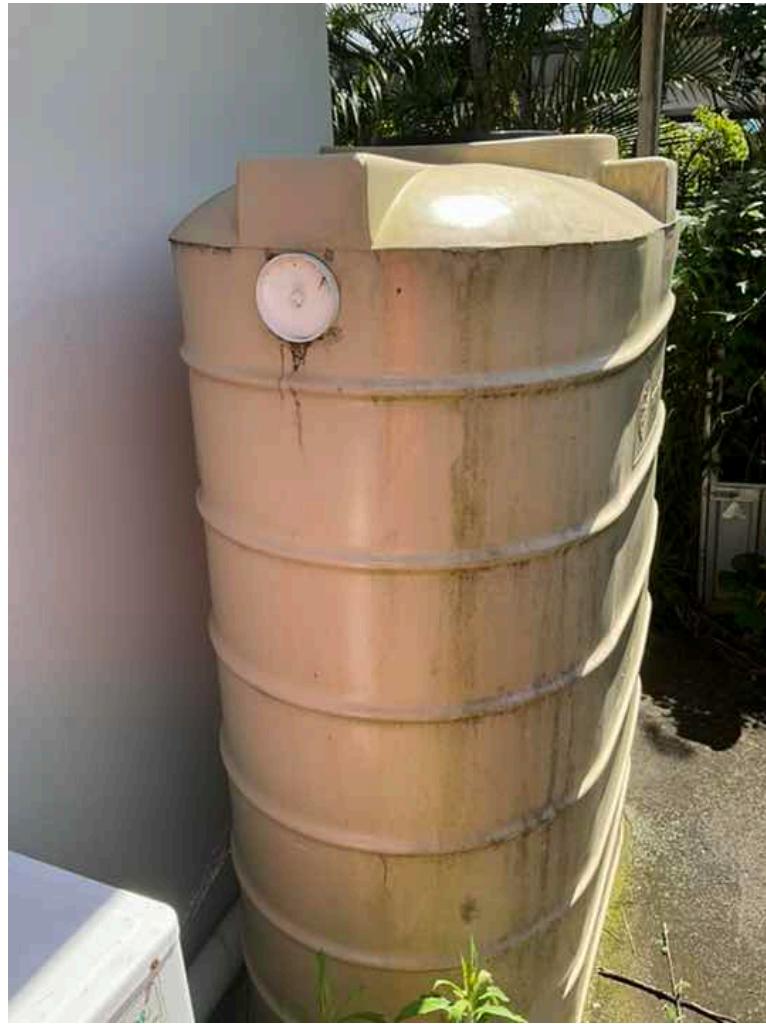
#23. Overflow not connected to point of discharge - This can be conducive to termite infestation and if close to the home can cause differential settlement in the homes footings and associated damp related problems.

Recommendations: Assessment conducted by a licensed plumber advised.

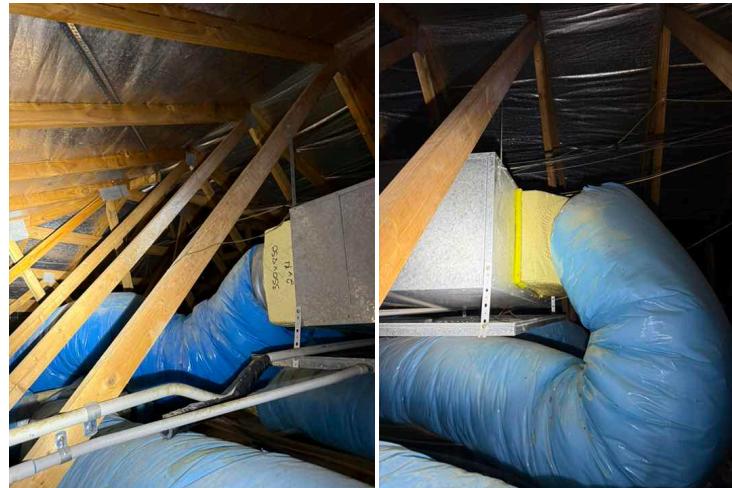
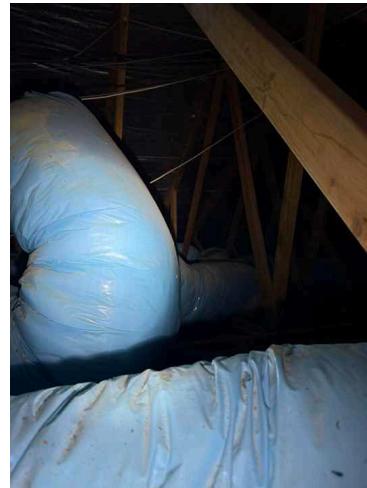
## Condition defects

EXTERIOR	Air Conditioner	Condition defects	<p>#32.</p> <p>Air conditioning ductwork must be suspended in accordance with Australian standard 4254.1–2012 and the National construction code. Flexible ductwork should be supported horizontally every 1.5 m and vertically every 1.8 m. The maximum sag between Support is 2.5 cm per 30 cm of horizontal run.</p> <p>Long horizontal duct with sharp bends should have additional support.</p> <p>The hanger or saddle material should be wide enough to prevent restricting the ducts internal diameter. A semi rigid fire resistant load distributing support material must be at least 75 mm wide.</p> <p>Flexible ductwork Installed in subfloor site must be supported so that no part of the duct touches the ground. All flexible ductwork must be labelled flexible ductwork must extend straight for 100 mm from the connection to an air terminal device before changing direction.</p> <p>Consult and air-conditioning specialist for rectification.</p>

#32.

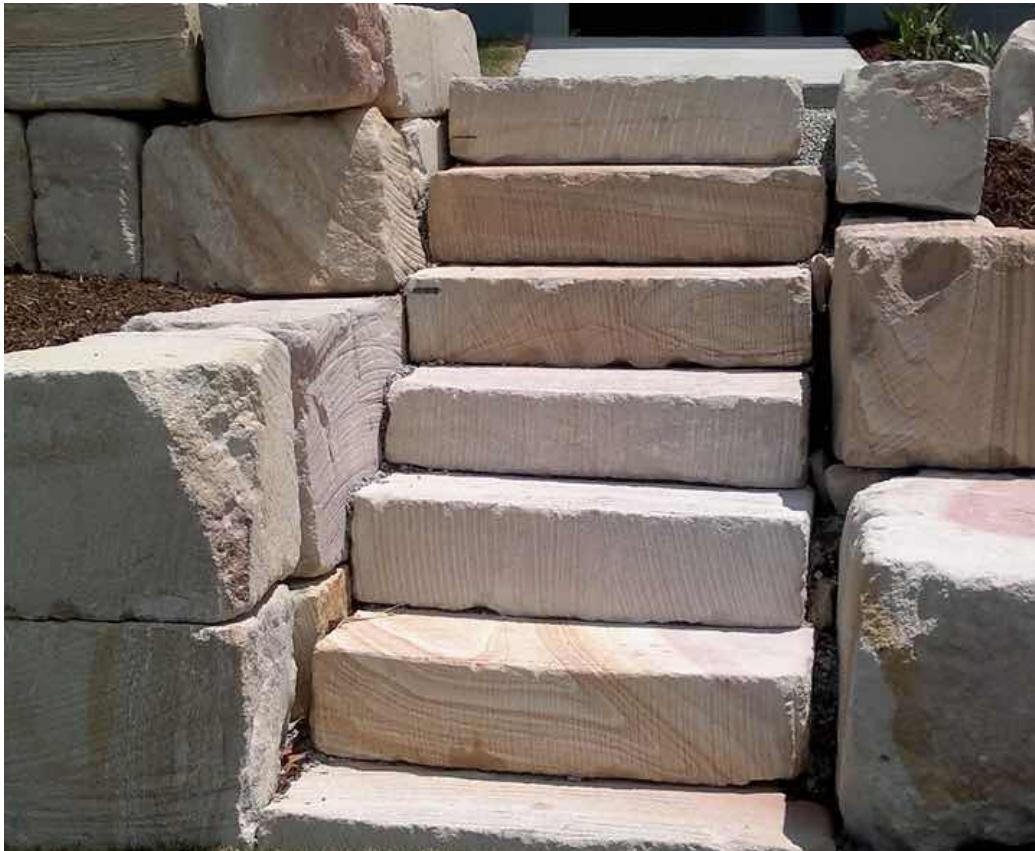
### Balustrade and Rails

#35. The stairs do not have an approved handrail. The National Construction Code of 2015 3.9.2.4 (a) Handrails to a Starway must (1) be located along at least one side of a flight or ramp and, (2) be located along the full length of the flight or ramp (3) have a top surface of the handrail not less than 865 mm vertically above the treads . NCC 3.9.2.4 (b) If there is a winder or turn on the stairs a newel post or handrail is required . and AS 1657-2013. Every stairway will be provided with at least one handrail, where there is more than 5 stairs or the height is more than 1 meter and on a wind. Consult a qualified tradesman for advice.

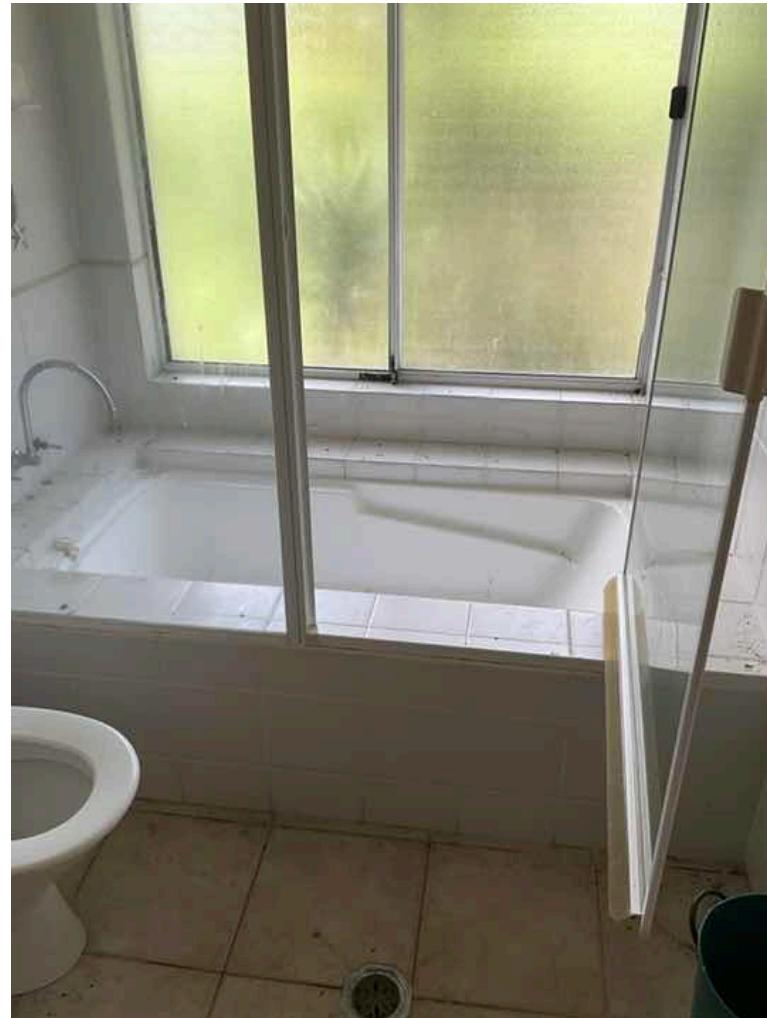
#### **Overall Condition**

#46. Aged renovate. Consult QBCC licensed builder.

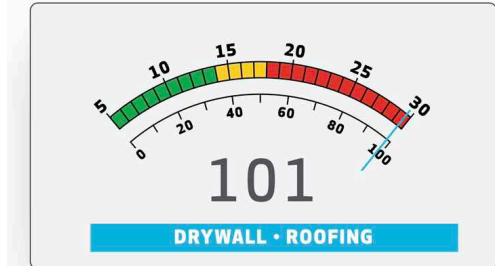
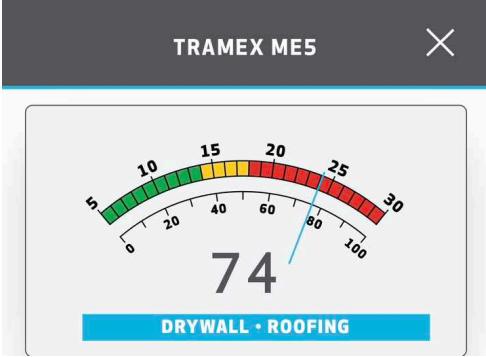
TRAMEX ME5

BATHROOM(S)	Bathroom 1	Overall Condition	#46. Aged renovate. Consult QBCC licensed builder.
BATHROOM(S)	Bathroom 2	Shower And Bath	#49. Hig moisture readings detected in cavity wall. Consult QBCC qualified waterproof specialist.
BATHROOM(S)	Bathroom 2	Shower And Bath	#50. High moisture readings in cavity wall. A flood and pressure test for the pipework and membrane should be conducted. Consult QBCC qualified plumber.
TIMBER PEST FINDINGS	4. Timber Fungal Decay - Rot	Evidence of Wood Decay Fungi -Rot	#52. Yes, in the following areas deck area. Area requires a treatment. Contact a license pest company.

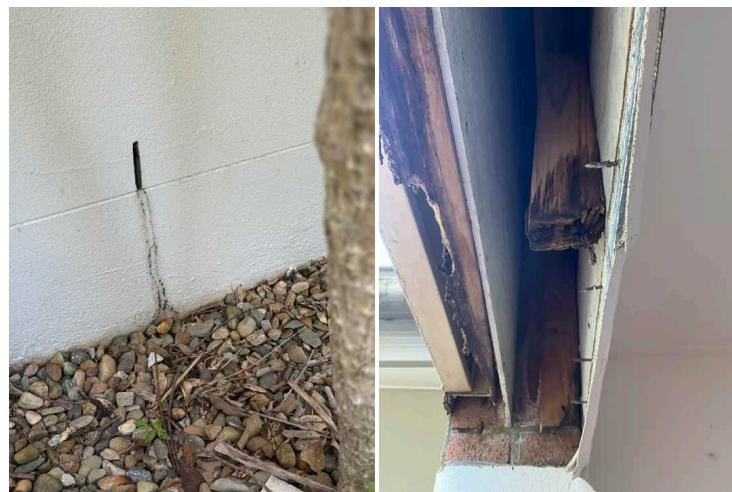
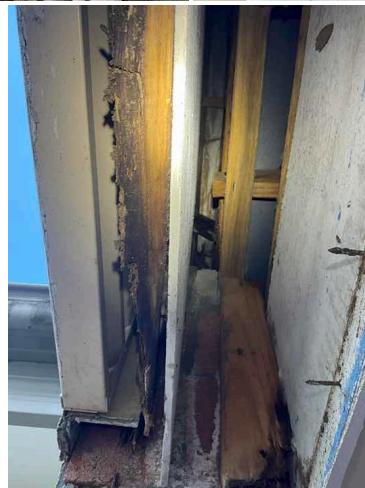
##### **Any workings or damage found**

Yes, termite damage was found in the following

Where evidence of termite activity was found in the grounds then the risk to buildings is very high. A treatment to eradicate the termites and to protect the building(s) should be carried out. Where the evidence of termite workings was found in the grounds or the building(s) then the risk of a further attack is very high.

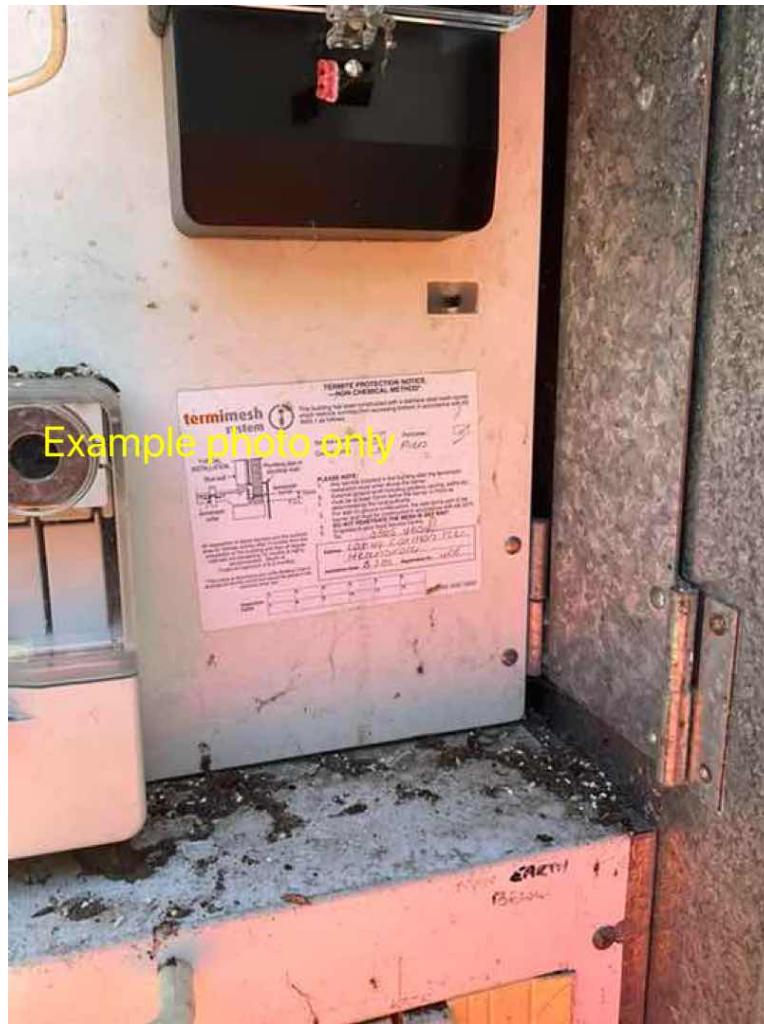
### Any Evidence of previous Treatments Found

A durable notice.

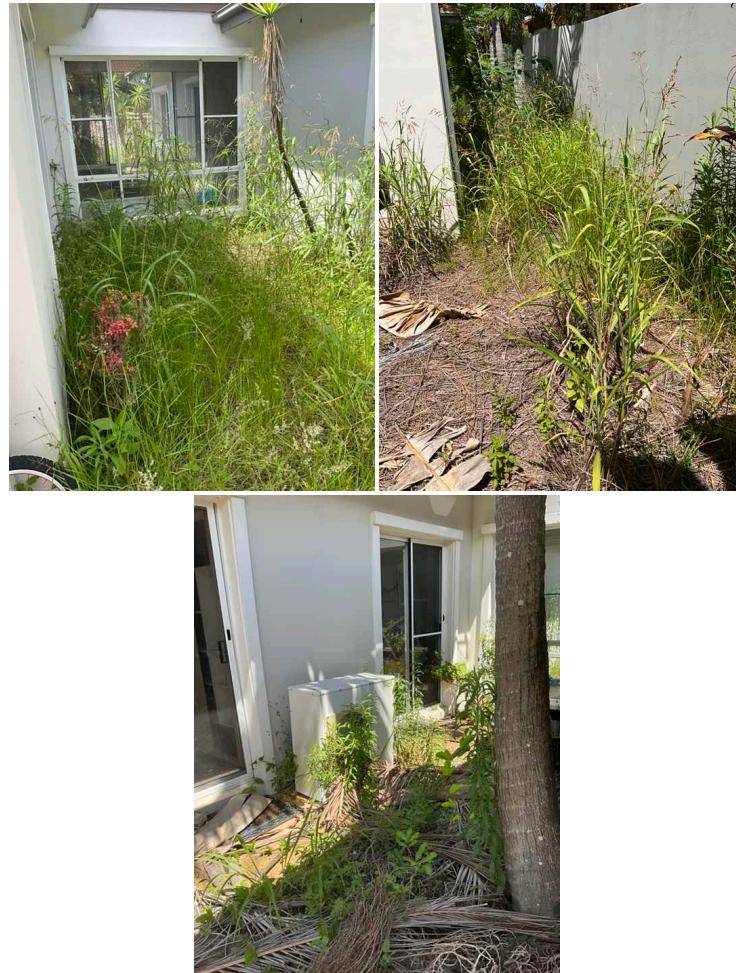
### **Is the Slab Edge adequately Exposed**

No. Slab edge should be exposed a minimum of 75mm.
